Some Reye AP can't be online on SON

I. Applicable Scenarios

RAP or EAP series products of Reye may not be discovered in a network. A L2 topology is taken as an example in this document to describe the troubleshooting of this issue.

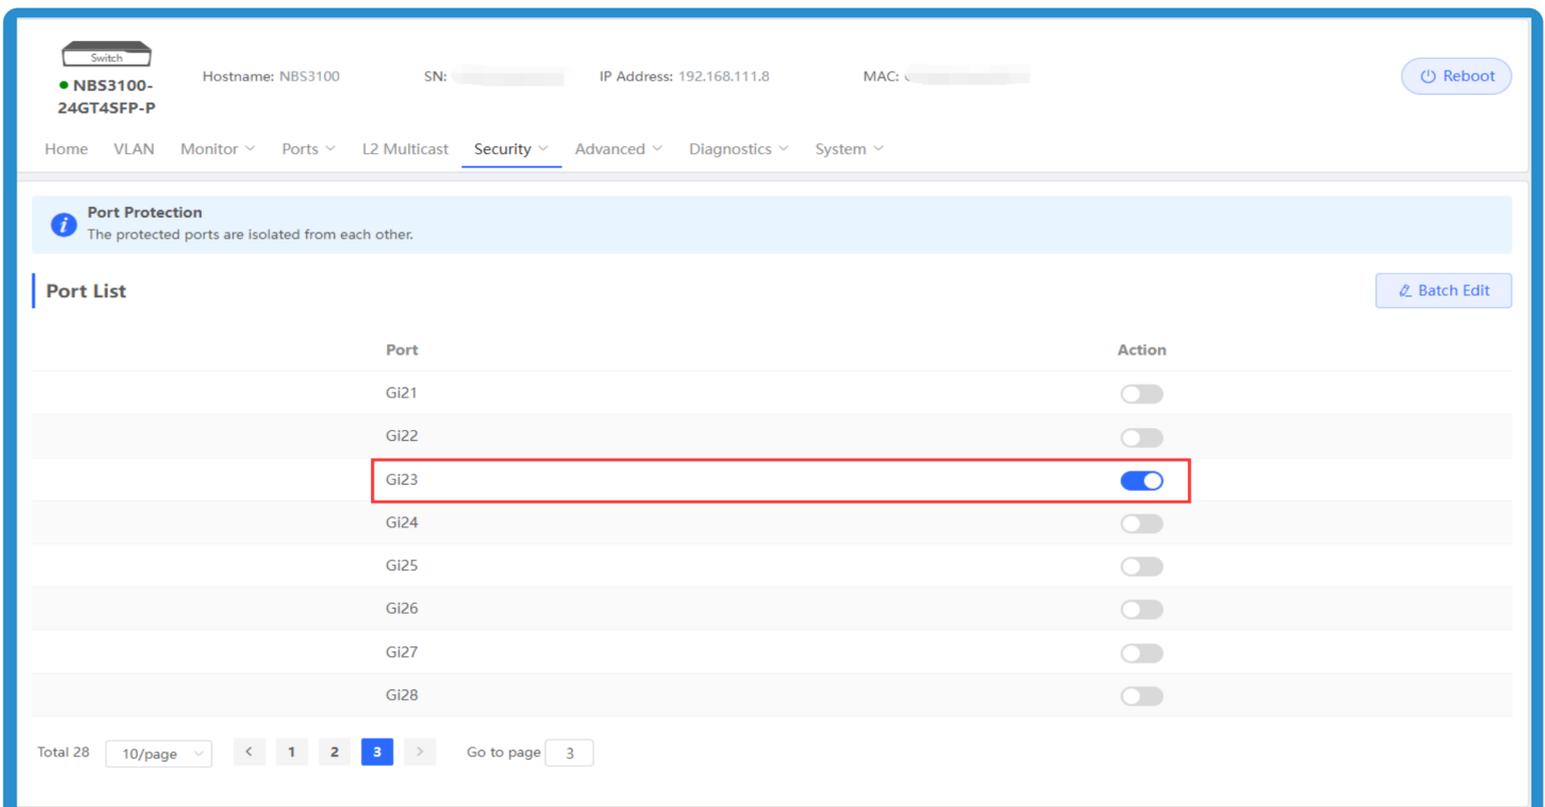
- B. If IP addresses can be obtained, run the ping command to test whether other APs can be pinged. If not, L2 isolation is enabled on a port in the internal switch to limit other switch ports. Log in to the access switch and choose **Security > Port Protection** to check whether the port protection function is enabled on the corresponding port and causes communication failure between ports. If yes, disable the port protection function on the port. The AP can communicate with other APs.

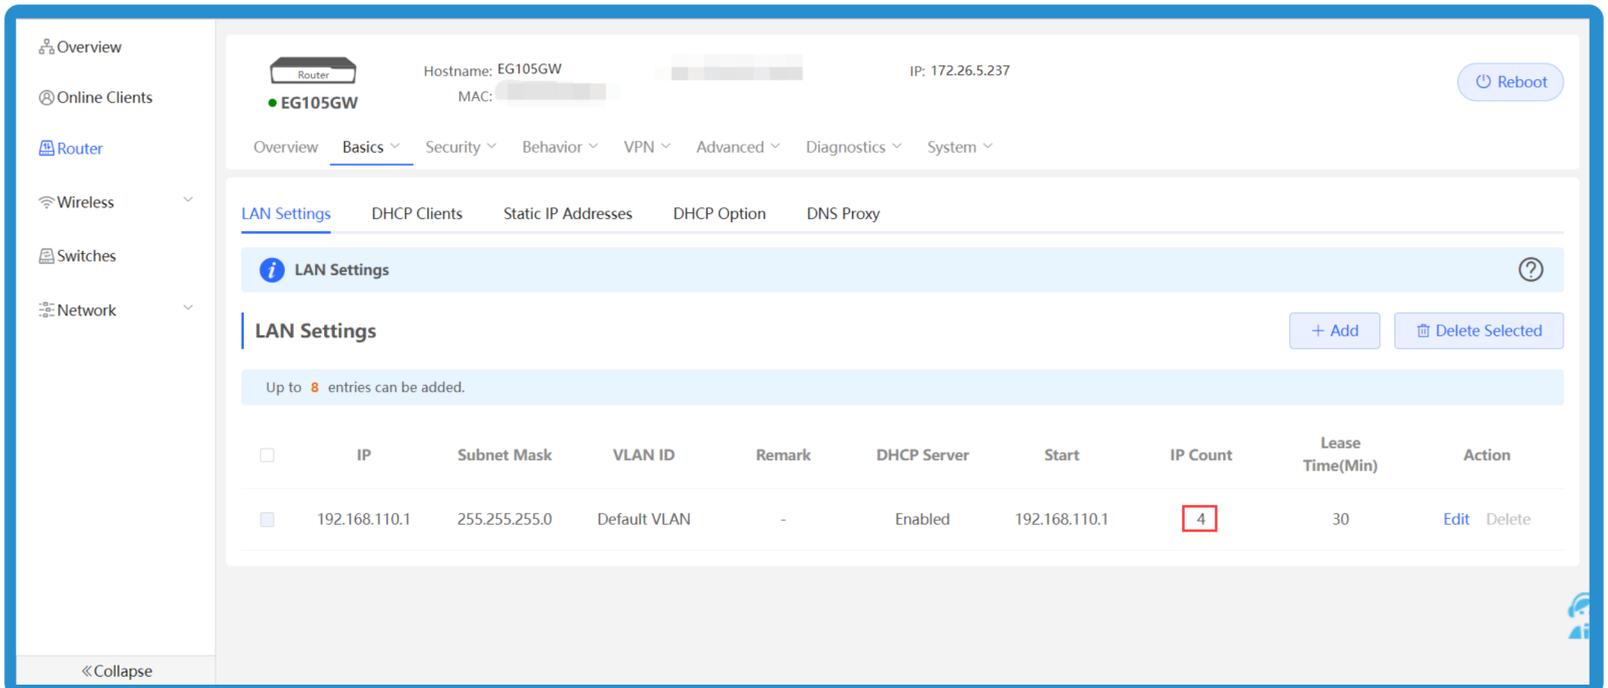
(2) Check the DHCP server configuration.

Check whether all DHCP addresses are allocated and cannot be released. Log in to the DHCP gateway and choose **Basics > LAN Settings**. The number of the IP addresses is 4 and they are all occupied. Increase the number of IP addresses so that they can be obtained through the AP.

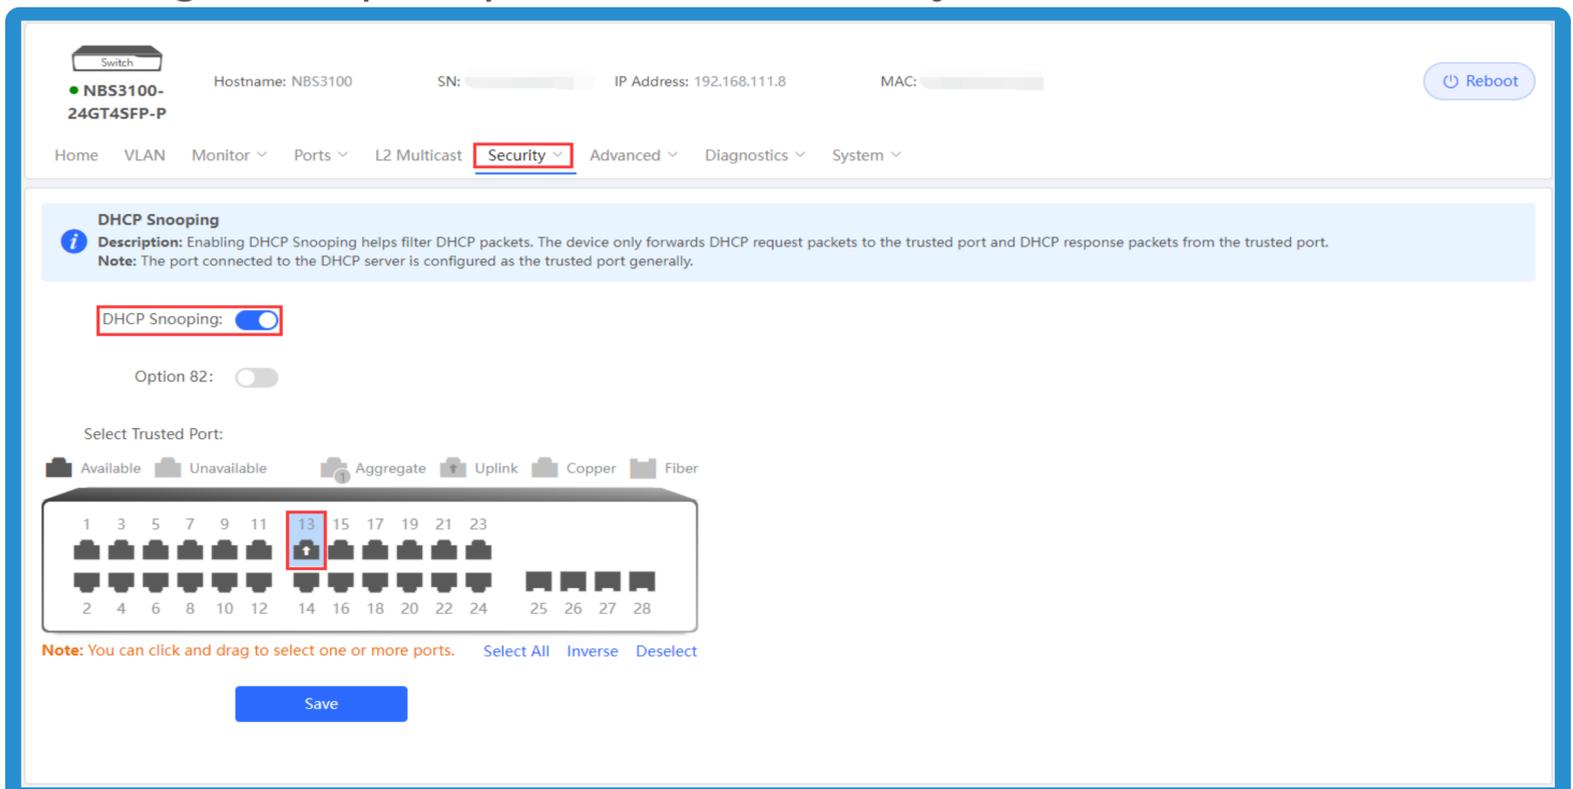
2 An AP obtains an incorrect IP address.

Check whether a router is connected to the intranet without authorization.

Check whether the physical port of the switch is connected to a router without authorization, causing the AP to obtain IP addresses through the DHCP server connected to this router. Log in to the switch, click the **Security** tab, enable **DHCP Snooping**, select port 13, and click **Save**. Port 13 is the uplink port of the switch and is configured as a trusted port to ensure that DHCP data delivered through the uplink port can be normally transmitted.

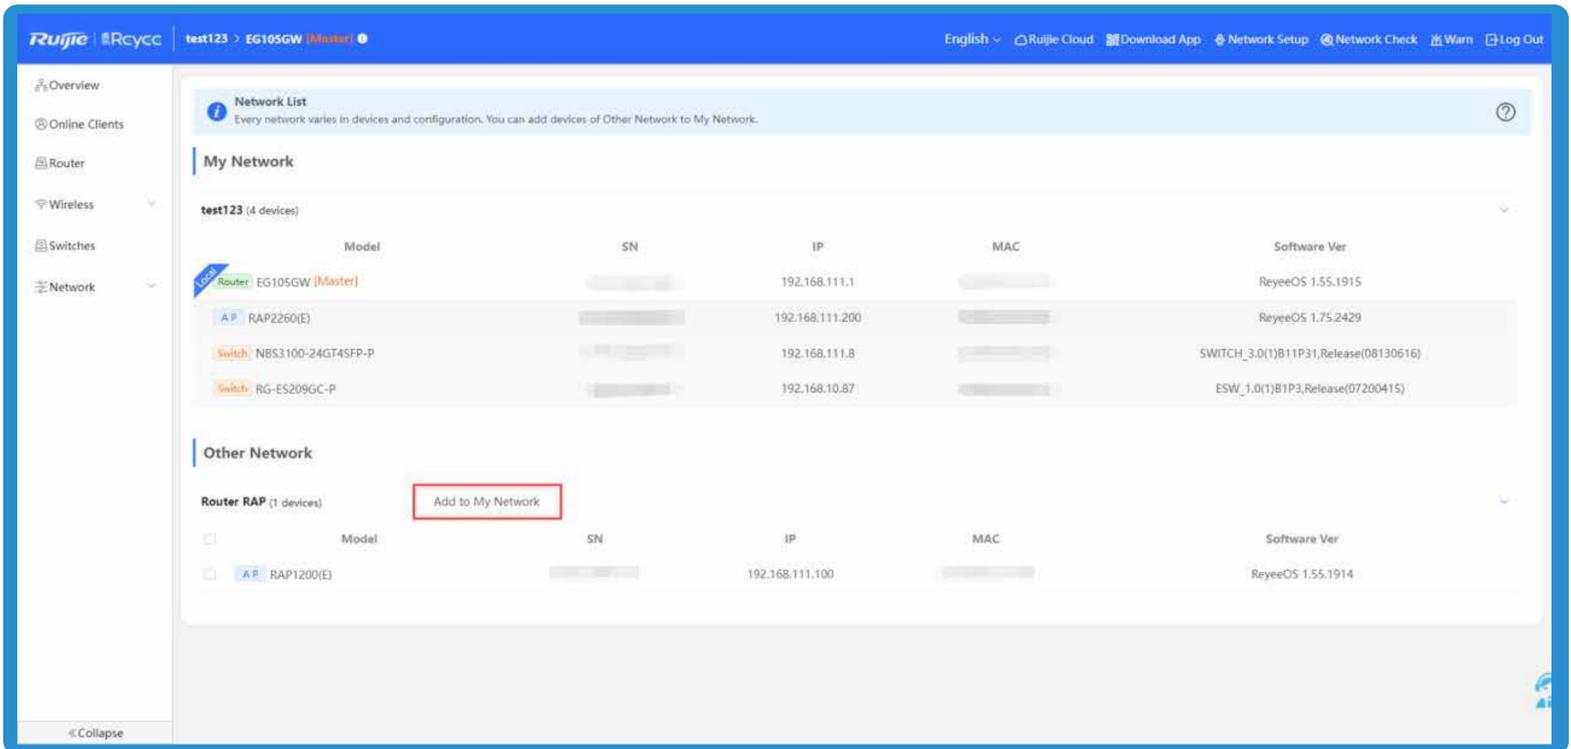
- 3 An AP is connected to a SON of other devices.
Restore the factory setting of the AP.
If the AP is connected to a SON of other devices, **Add to My Network** is displayed on the interface. You need to reset the AP and connect it to the new SON.

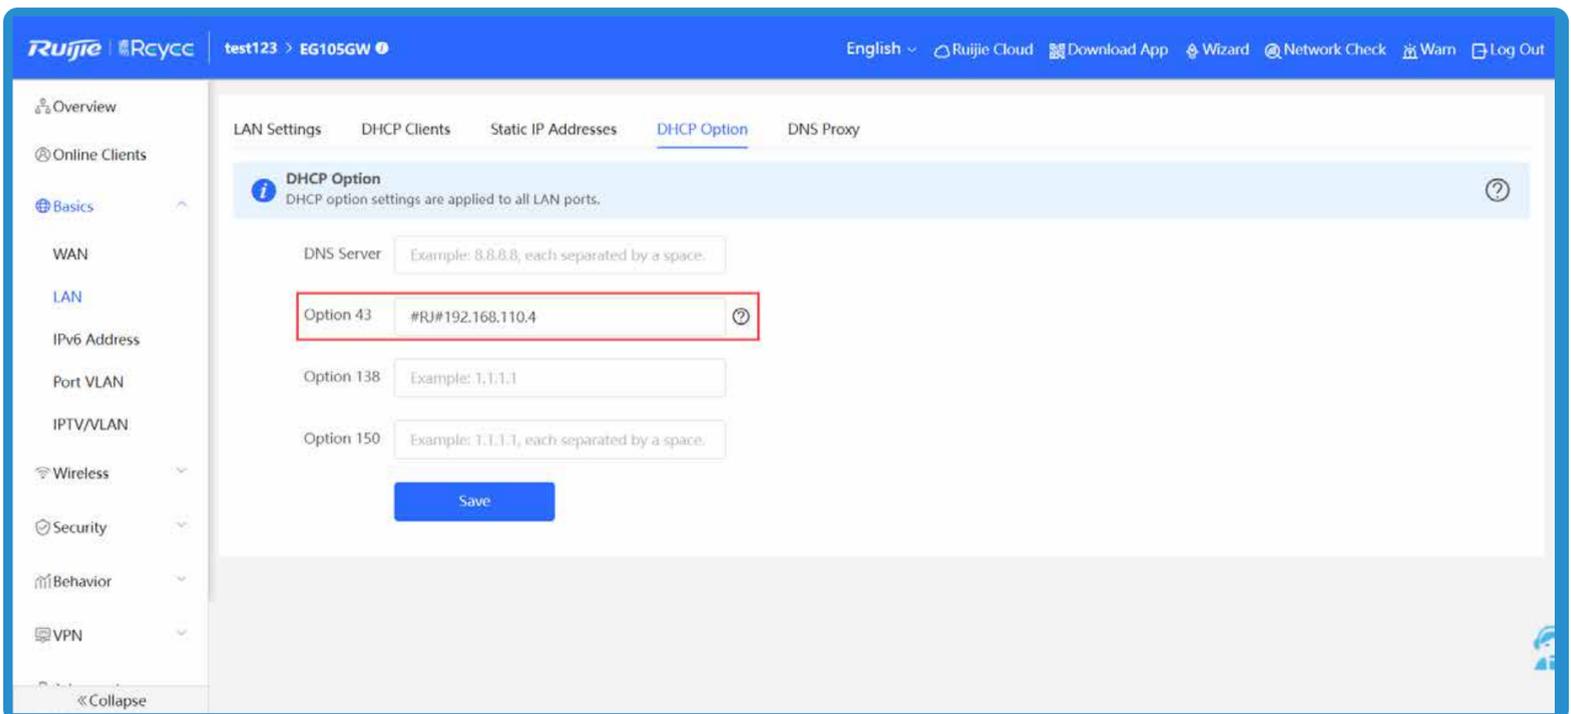
- 4 An AP is not located in the same network segment as the main device.
Check whether the intranet is divided into multiple network segments. An AP cannot be connected to a SON by crossing a network segment.
An AP is connected to a SON in broadcast mode and this cannot be implemented crossing networks. To enable SON connection crossing a network segment, log in to the DHCP gateway, for example, Reyeeg EG105GW, and disable the SON function of the gateway. Choose **Basics > LAN > DHCP Option** and configure the **Option 43** field as the IP address of the main AP in the format of **#RJ#main AP IP address**.
